Lancaster 3-story Office Bldg  
CSMIP Station No. 24517

SENSOR LOCATIONS

Reinstrumented: 02/14/2024  
Diagram: 04/05/2024 rev.

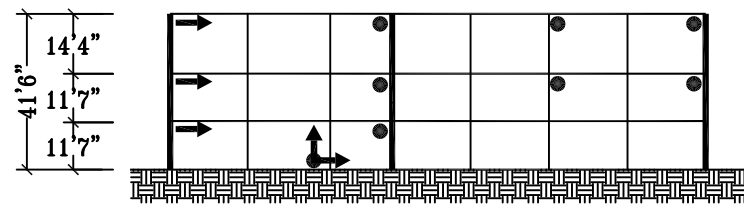
S/N Elevation

Roof  
3rd Floor  
2nd Floor  
Ground Floor

Reinforced Masonry  
Shear Walls
