SENSOR LOCATIONS

Colton - 1-story School Gym  
(CSMIP Station No. 23540)

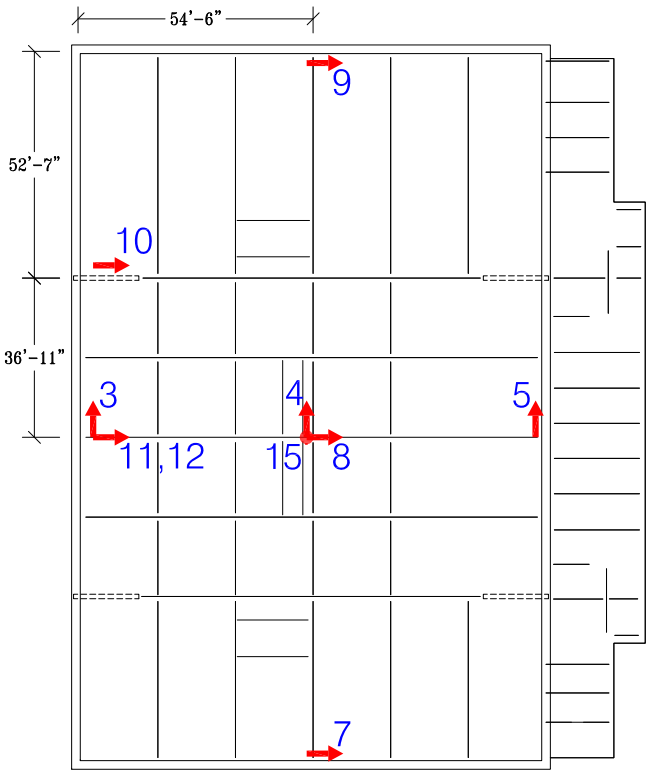
Top of Walls/Roof Plan

Note: Sensors 14 & 15 Added  
During 2025 Reinstrumentation.
