# Gilroy - 2-story Hospital (CSMIP Station No. 57200)

## SENSOR LOCATIONS

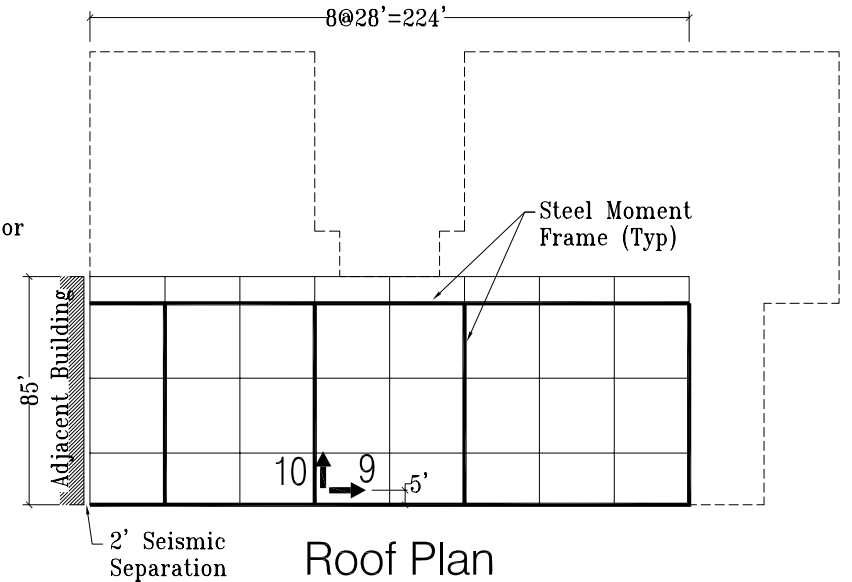
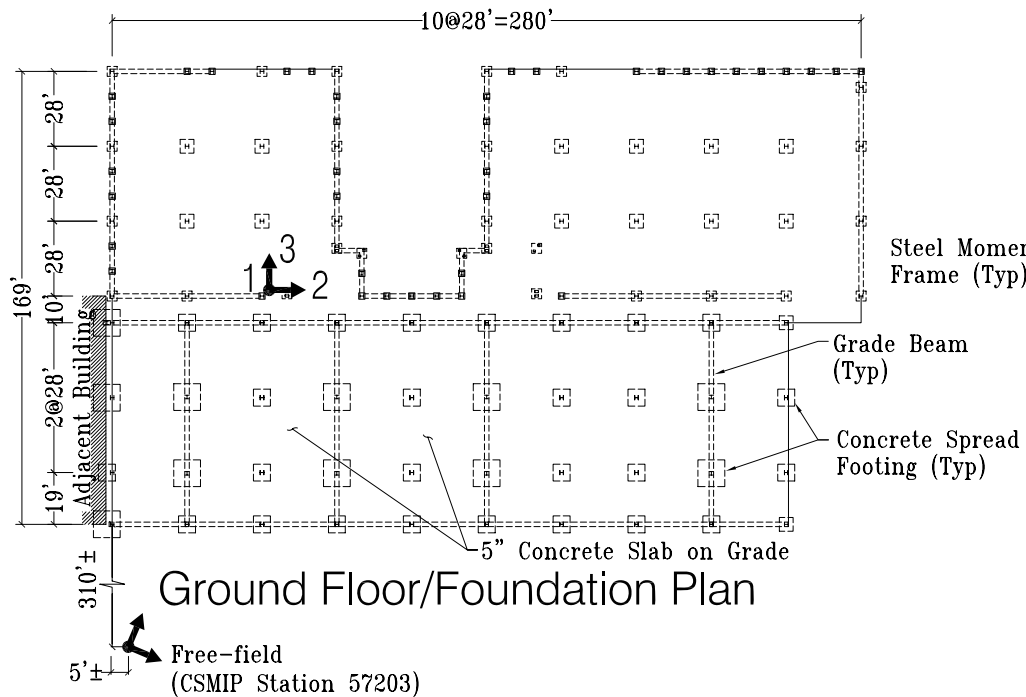
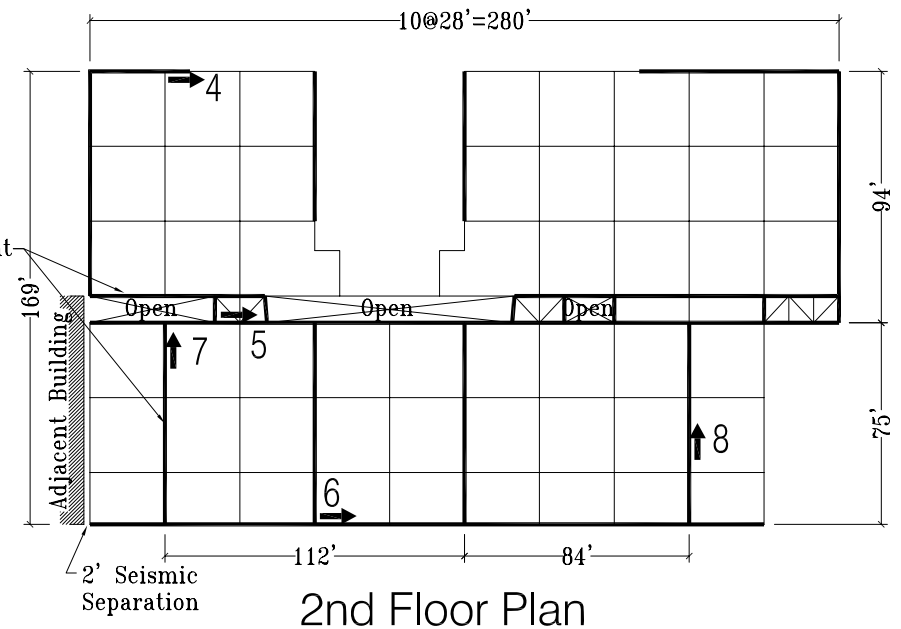
Roof  
2nd Floor  
Ground Floor

Structure Reference  
Orientation:  $N_{ref} = 338^\circ$
