**U.S. Department of Veterans Affairs**  
**CA: Livermore, Livermore Building No. 62 - Reinforced Concrete, Six-Story Hospital Building**  
**NSMP Station No: 1226**  
 Data represented by station.channel.network.location (SCNL) (i.e. 1226.HNN.NP.01 (390°))

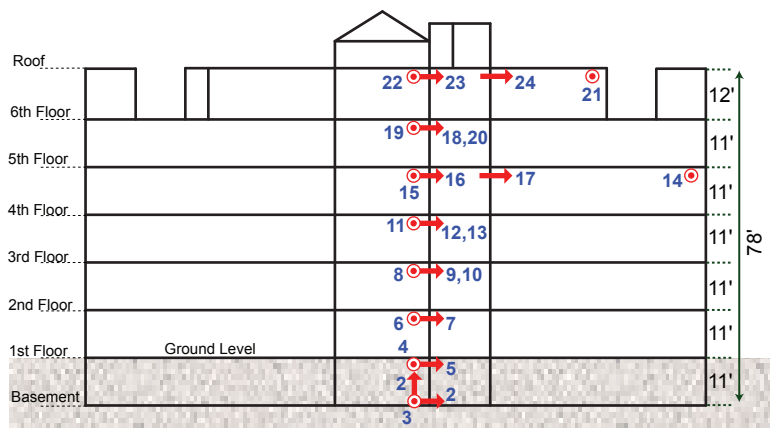
Elevation View Looking Reference South  
 The vertical to horizontal scale factor is 2

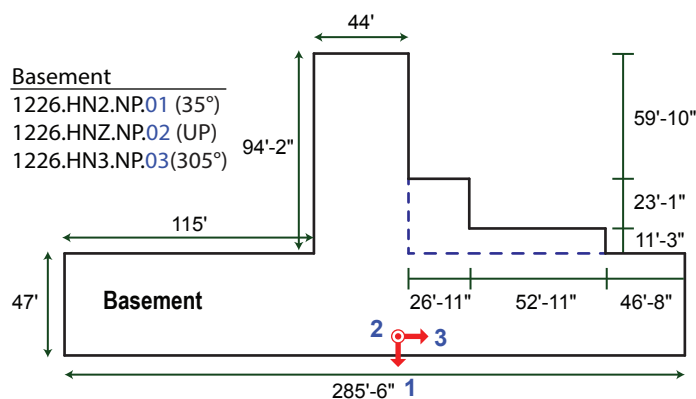
**First Floor**  
 1226.HN2.NP.04 (35°)  
 1226.HN3.NP.05 (305°)  
 1226.HN2.NP.06 (35°)

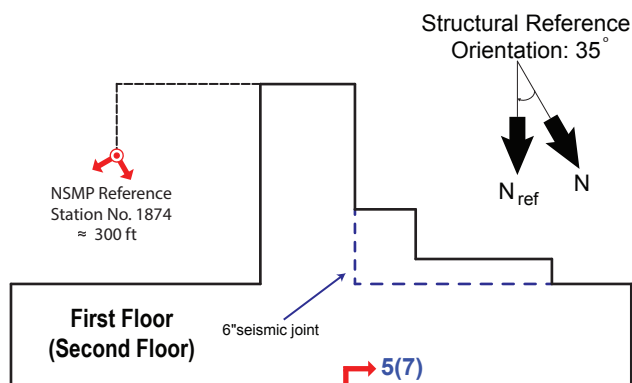
**(Second Floor)**  
 1226.HN3.NP.06 (35°)  
 1226.HN2.NP.07 (305°)

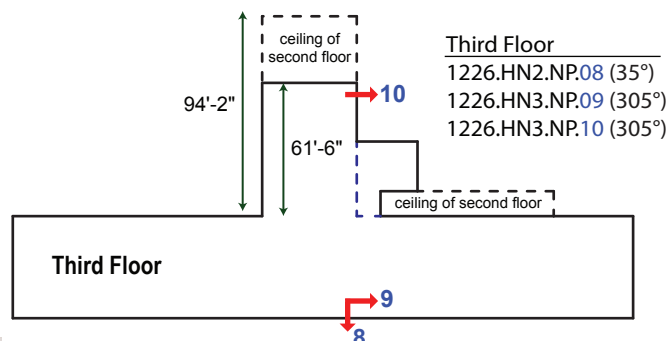
**Third Floor**  
 1226.HN2.NP.08 (35°)  
 1226.HN3.NP.09 (305°)  
 1226.HN3.NP.10 (305°)

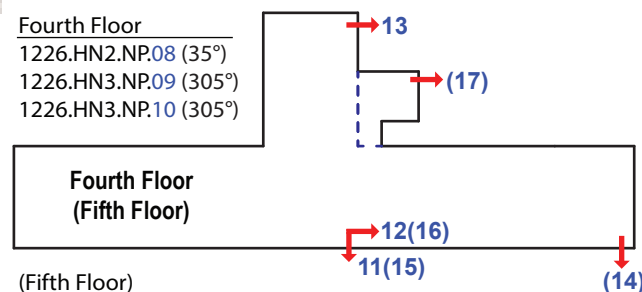
**(Fifth Floor)**  
 1226.HN2.NP.08 (35°)  
 1226.HN3.NP.09 (305°)  
 1226.HN3.NP.10 (305°)

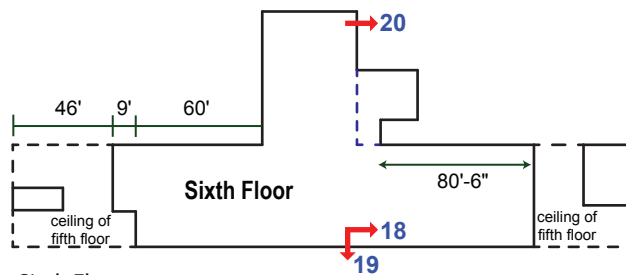
**Sixth Floor**  
 1226.HN2.NP.08 (35°)  
 1226.HN3.NP.09 (305°)  
 1226.HN3.NP.10 (305°)

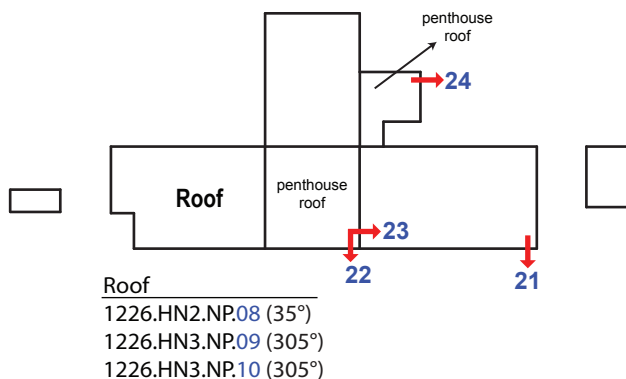
**Roof**  
 1226.HN2.NP.08 (35°)  
 1226.HN3.NP.09 (305°)  
 1226.HN3.NP.10 (305°)
