CA: Palo Alto, Channing House - 10 Story Residential Building
 NSMP Station No: 1811

Data represented by station.channel.network.location (SCNL) (i.e. 1811.HN2.NP.2A (25°))

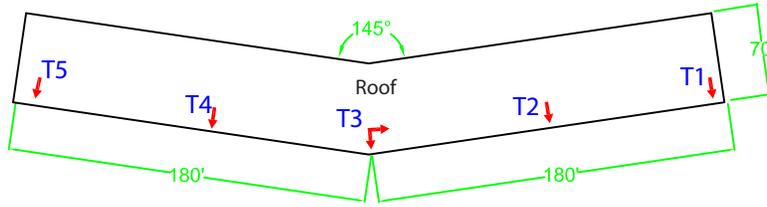
Roof Channels

(located on 10th Floor Ceiling)	(located on 11th Floor)
1811.HN2.NP.T1 (25°)	1811.HN2.NP.T3 (25°)
1811.HN2.NP.T2 (25°)	1811.HN3.NP.T3 (295°)
1811.HN3.NP.T4 (55°)	
1811.HN3.NP.T5 (55°)

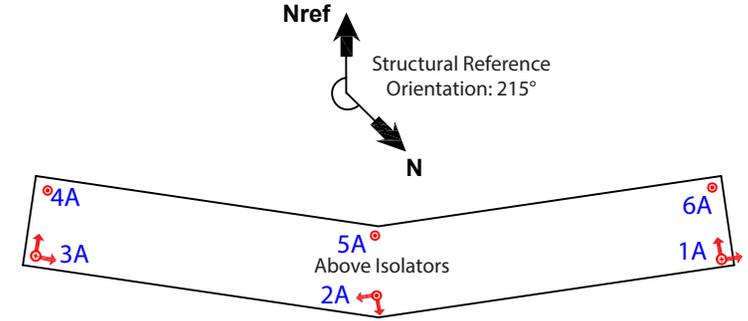
Basement (Above Isolators) Channels

1811.HN2.NP.1A (205°)	1811.HN2.NP.3A (325°)
1811.HN3.NP.1A (295°)	1811.HN3.NP.3A (235°)
1811.HNZ.NP.1A (Down)	1811.HNZ.NP.3A (Down)
1811.HN2.NP.2A (25°)	1811.HNZ.NP.4A (Up)
1811.HN3.NP.2A (115°)	1811.HNZ.NP.5A (Up)
1811.HNZ.NP.2A (Up)	1811.HNZ.NP.6A (Up)

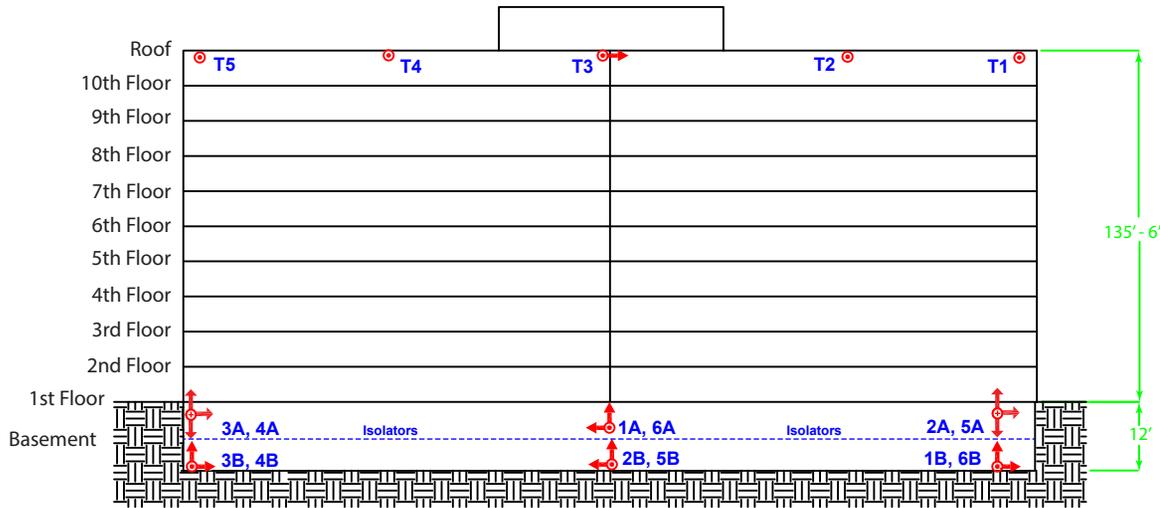
Elevation View Looking Reference North

Basement (Below Isolators) Channels

1811.HN2.NP.1B (25°)	1811.HN2.NP.3B (325°)
1811.HN3.NP.1B (295°)	1811.HN3.NP.3B (55°)
1811.HNZ.NP.1B (Up)	1811.HNZ.NP.3B (Up)
1811.HN2.NP.2B (25°)	1811.HNZ.NP.4B (Up)
1811.HN3.NP.2B (115°)	1811.HNZ.NP.5B (Up)
1811.HNZ.NP.2B (Up)	1811.HNZ.NP.6B (Up)
